Settlement: Lyde

Location of Investigation

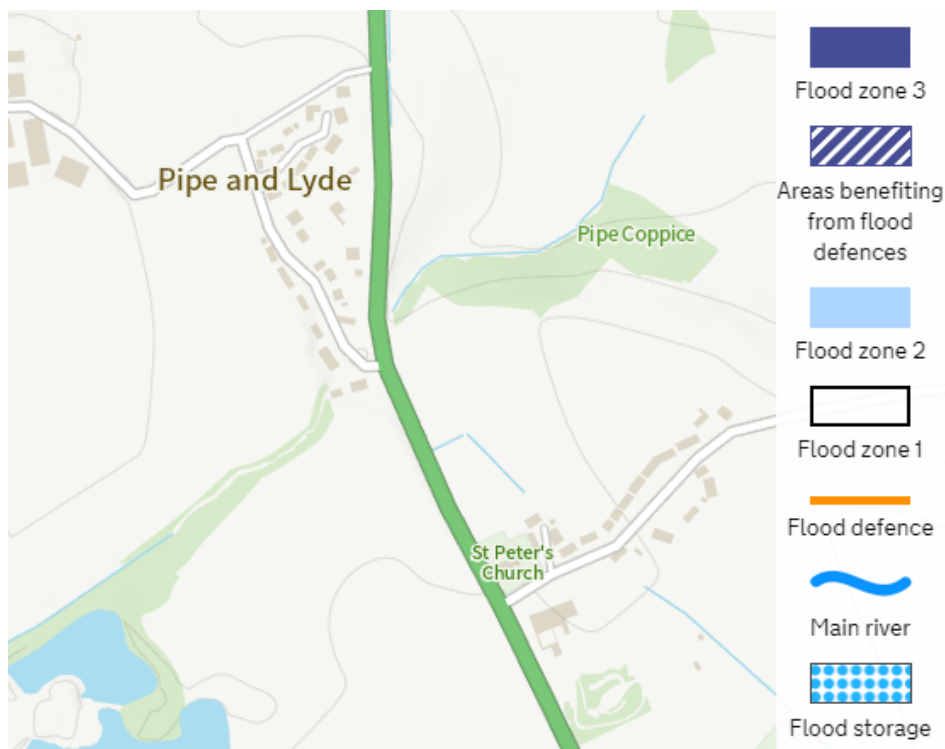
Figure 2: Environment Agency's Flood Map for Planning (Rivers and Sea), June 2021

The Flood Map for Planning indicates that the location is in Flood Zone 1. However, the Environment Agency Flood Mapping does not provide Flood Zones for watercourses with less than a 3km² catchment. It is possible that the site is located in Flood Zone 3.
