Settlement: Cobhall Common

Location of Investigation

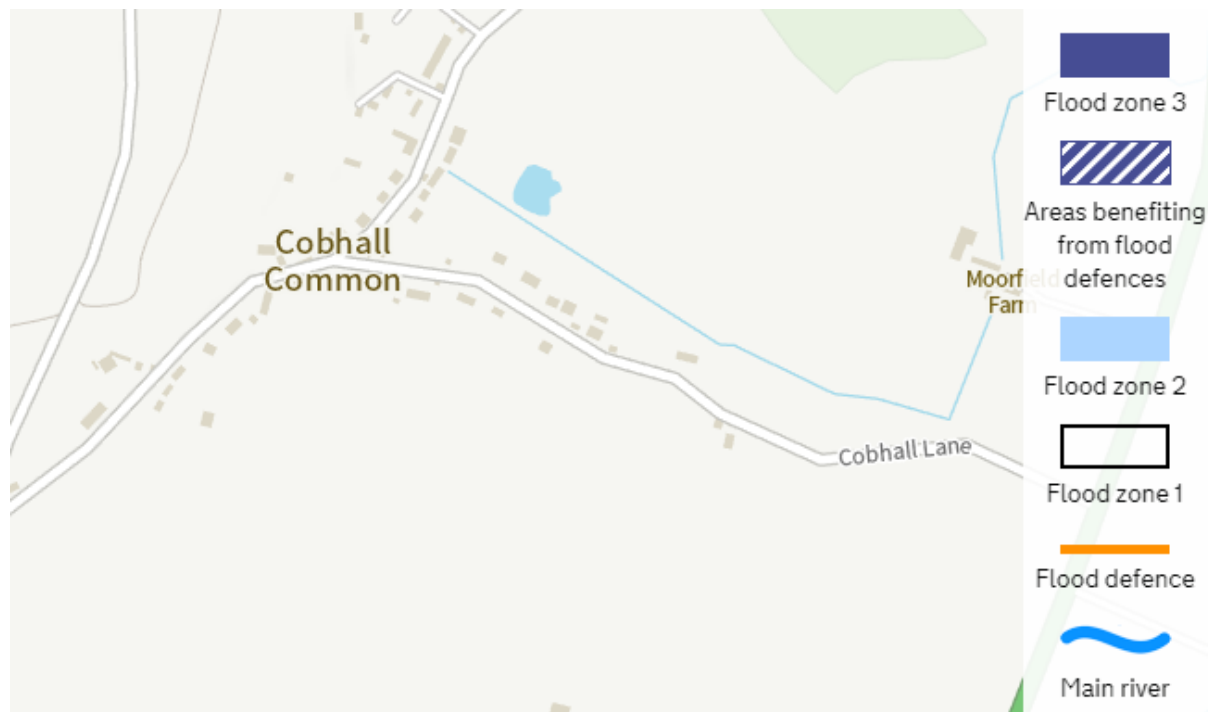
Figure 2: Environment Agency's Flood Map for Planning (Rivers and Sea), June 2021

The Flood Map for Planning indicates that all the properties which reported flooding in Cobhall Common are in Flood Zone 1. However, OS mapping shows small watercourses close to the affected properties that do not appear to have been included in this risk mapping. The EA Surface Water Flood Map indicates that all the properties which reported flooding in Cobhall Common are within or adjacent to areas at risk of surface water flooding.
