## Settlement: Moccas

## Key Flood Event

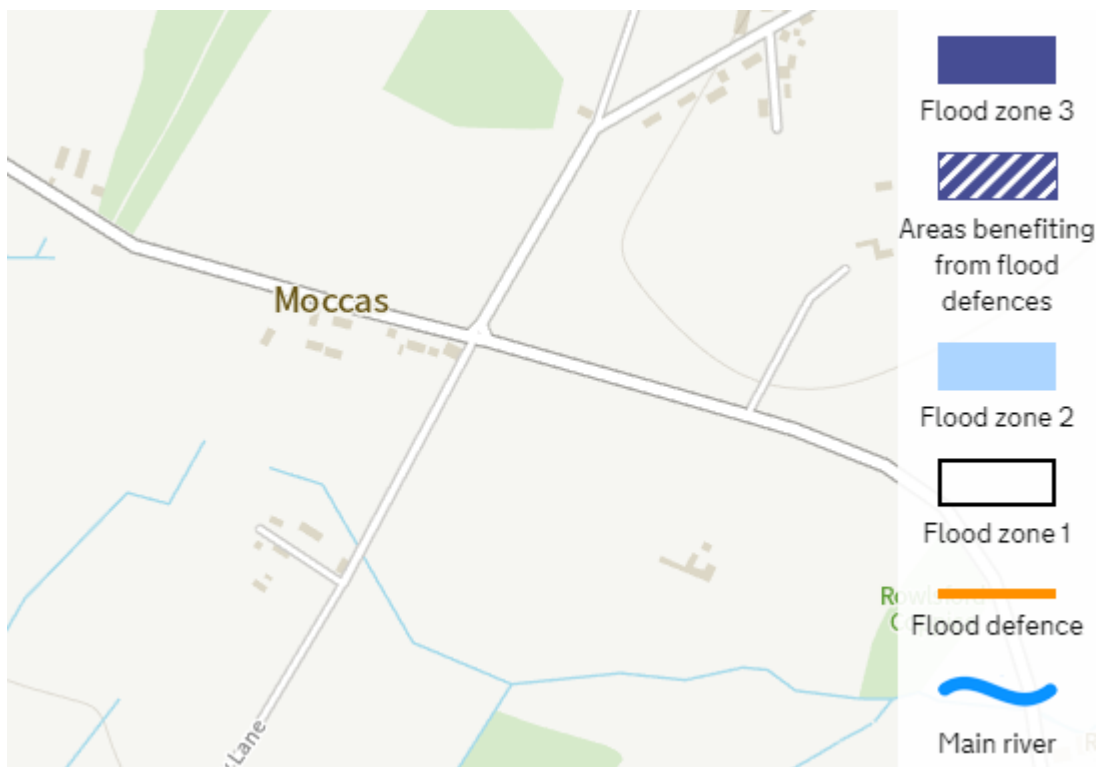
Figure 2: Environment Agency's Flood Map for Planning (Rivers and Sea), June 2021

The Flood Map for Planning indicates that all the properties which reported flooding in Moccas are in Flood Zone 1. However, OS mapping shows small, unnamed watercourses close to the affected properties that do not appear to have been included in this risk mapping. The EA Surface Water Flood Map indicates that all the properties which reported flooding in Moccas are within or adjacent to areas at risk of surface water flooding.
