## Settlement: Brimfield

## Key Flood Event

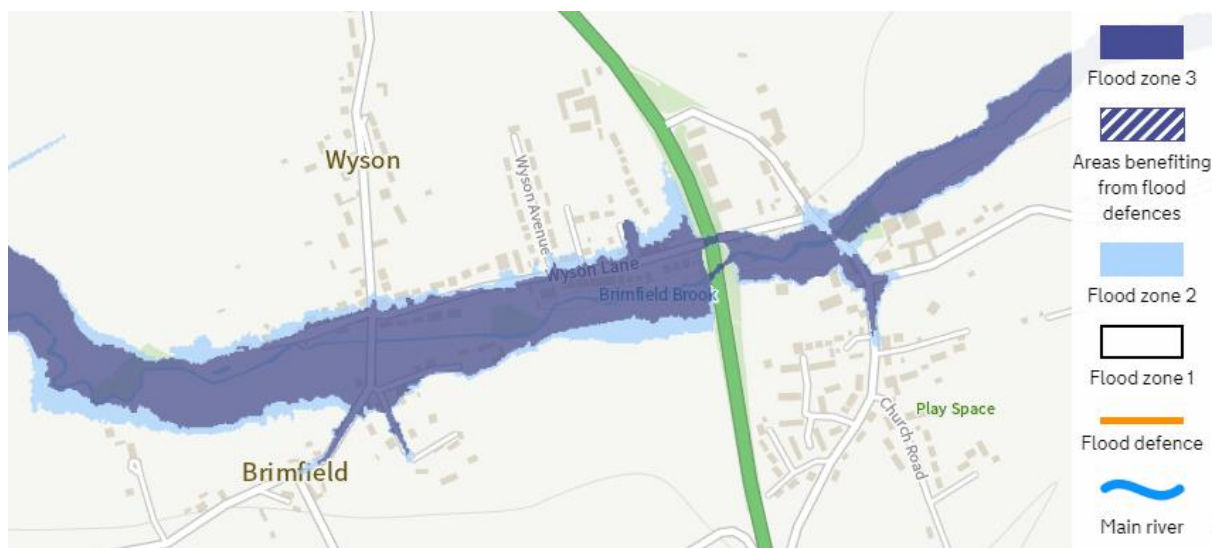
Figure 2: Environment Agency's Flood Map for Planning (Rivers and Sea), June 2021

The Flood Map for Planning indicates that all the properties that flooded are within Flood Zone 3 of the Brimfield Brook. The Surface Water Flood Map does not show any significant areas of flood risk which do not coincide with areas of flood risk identified on the Flood Map for Planning. This indicates that the source of flood risk in the area is fluvial flows from the Brimfield Brook.
