Settlement: Hereford (Newton Farm, Redhill)

Location of Investigation

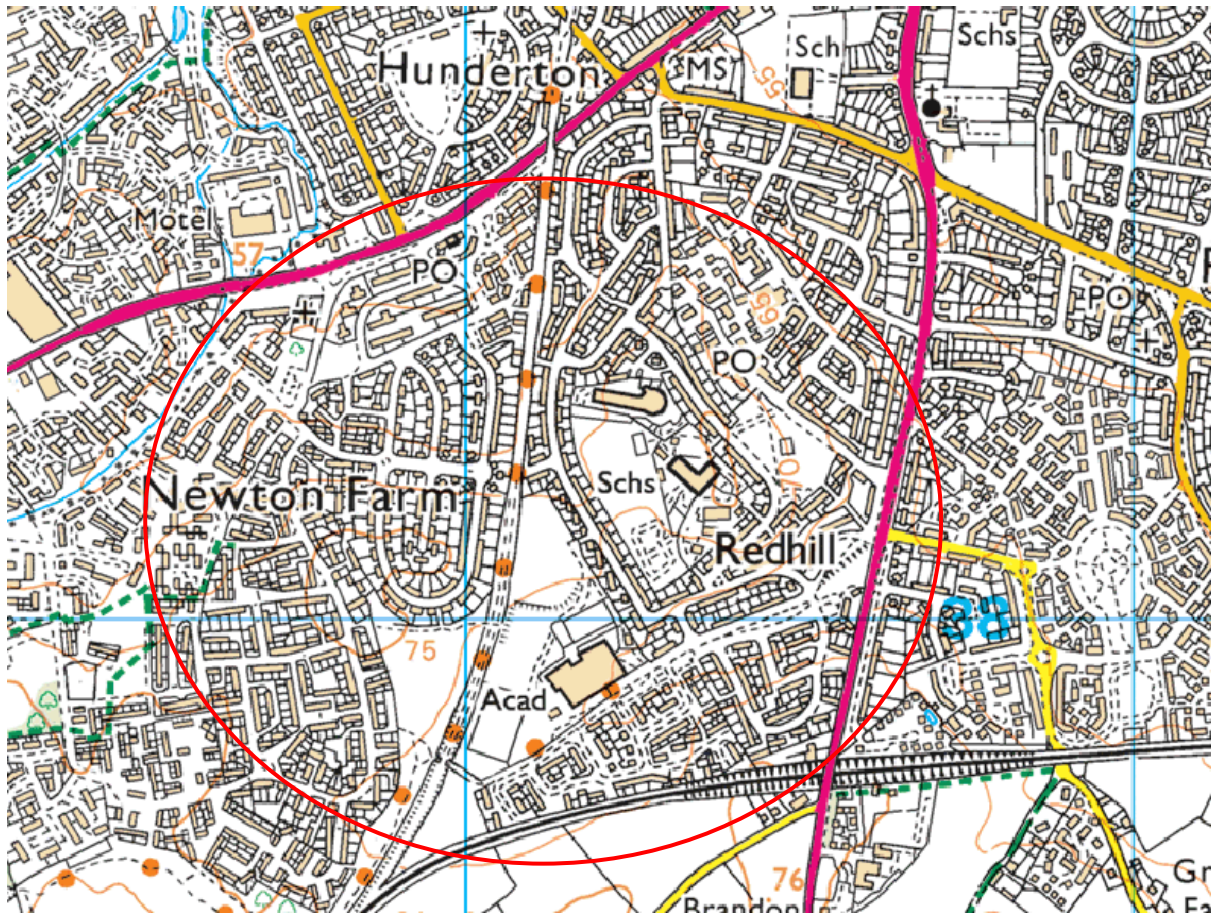
Figure 1: Large Scale Map showing the location of flooding within Newton Farm, Hereford

Two properties flooded from the Newton Brook.

There were two other locations where surface water flooding occurred.

The Surface Water Flood Map indicates an area of flood risk which coincides with the Newton Brook, where properties were reported as flooding in 2019 and 2020. The most likely flood mechanism for these properties is therefore fluvial flows from the Newton Brook. However, this is contradicted by a single report from a respondent on Belmont Road who indicated that an overflowing drainage system was the source of the flooding and described 'water and sewerage' entering.

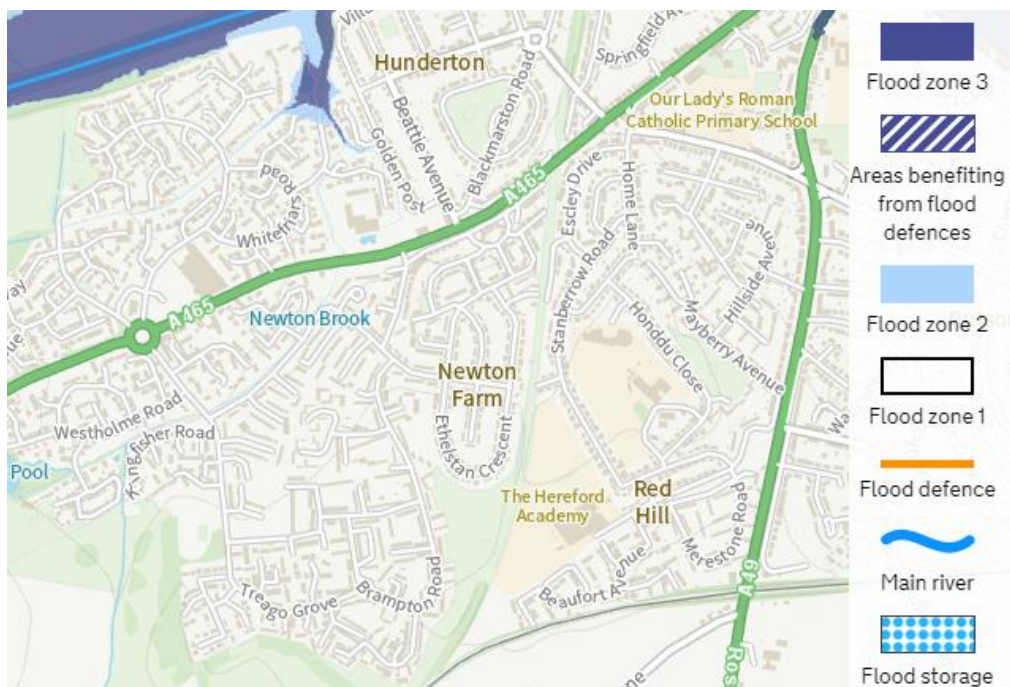
Figure 2: Environment Agency's Flood Map for Planning (Rivers and Sea), June 2021

The Flood Map for Planning shown above suggests that all of the properties which reported flooding are in Flood Zone 1, however the mapping does not consider flood risk from watercourses with catchments smaller than 3 km<sup>2</sup> and so the fluvial risk from the brook is not represented. The two properties are probably at risk of fluvial flooding from this source.
