Settlement: Kingstone

Key Flood Event

Flood Type: Surface Water & Public Sewer

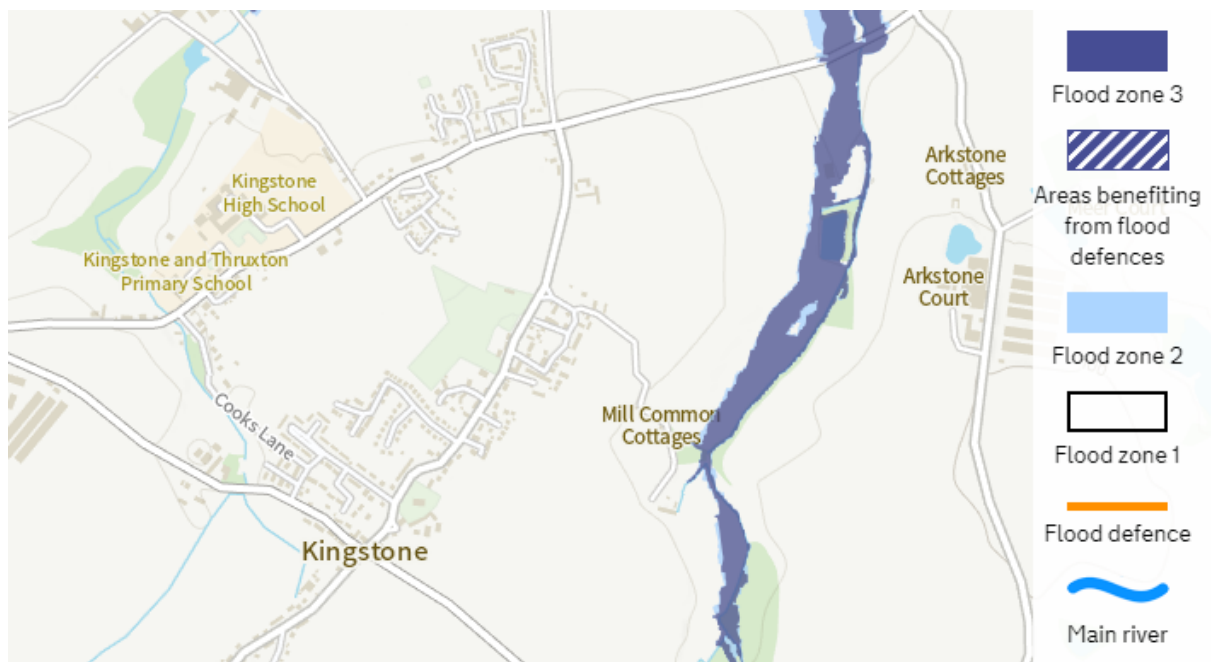
Figure 2: Environment Agency's Flood Map for Planning (Rivers and Sea), June 2021

The source of flooding in Kingstone is most likely to be from overland flows. The Flood Map for Planning indicates that all the properties which reported flooding in Kingstone are in Flood Zone 1. The EA Surface Water Flood Map indicates these properties are in areas at risk of surface water flooding. This is supported by the survey responses reviewed for this study. The survey responses indicated that previous flooding was caused by field run-off during the heavy rains in 2019. The two respondents which have provided information on the source of the flooding in 2020 attribute it to surface water runoff, as well as overflowing sewers and a blocked gully. Although one of the respondents also mentions groundwater. One respondent also raises concerns about surface water drainage with respect to recent development.
