**Settlement Name** Clehonger

**Site Ref** HLAA/345/001

**Site Address** Land adjacent to Shark House

## Assessment of land with housing potential- Clehonger

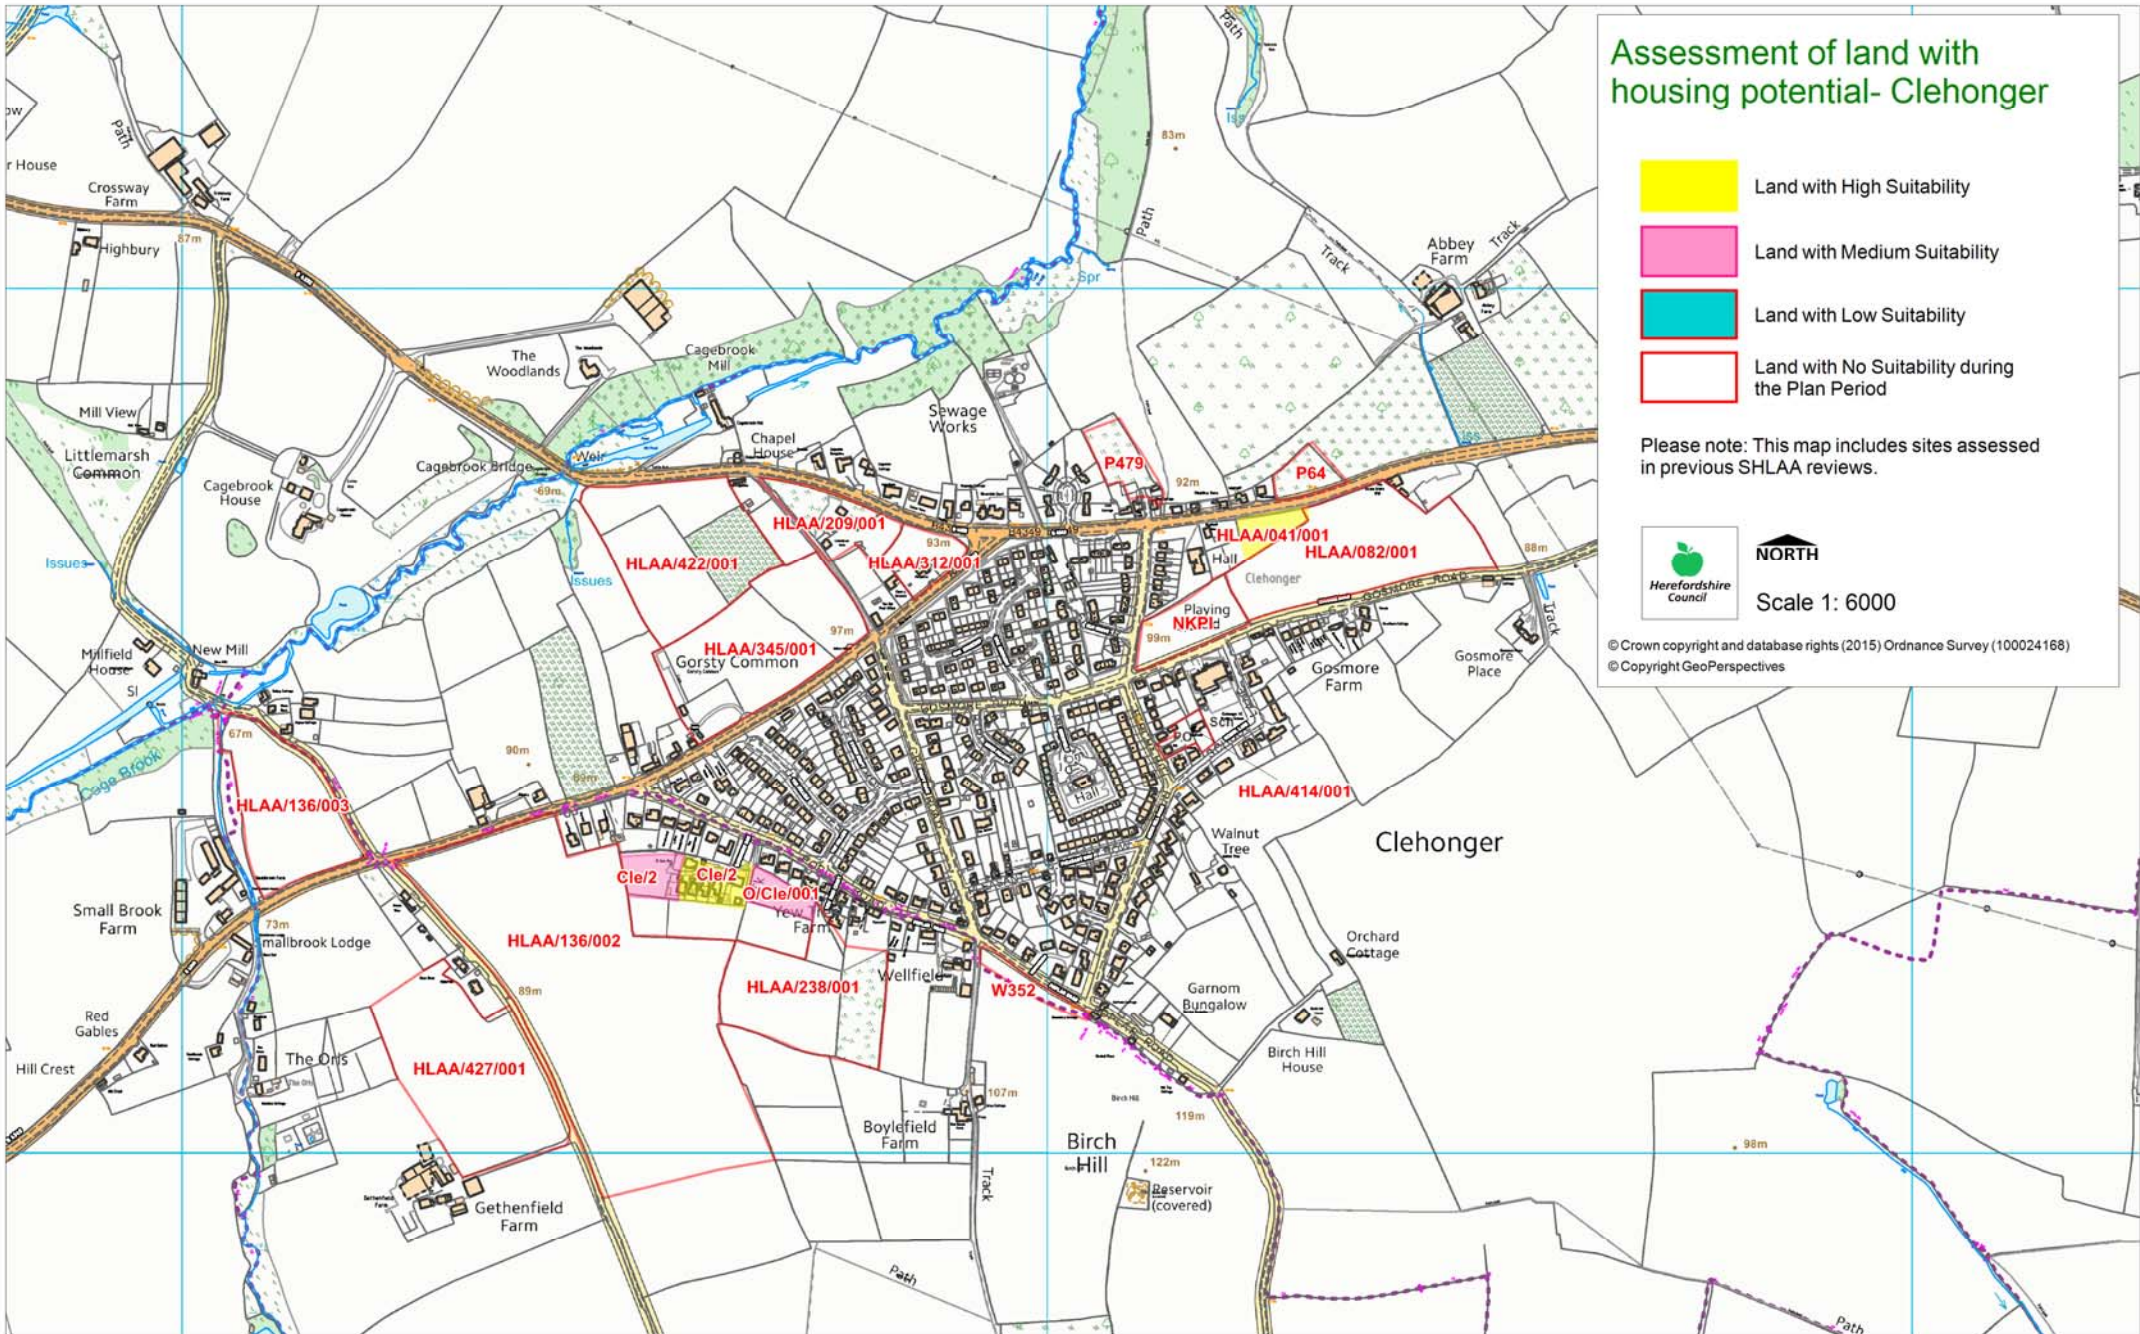
- Land with High Suitability
- Land with Medium Suitability
- Land with Low Suitability
- Land with No Suitability during the Plan Period

Please note: This map includes sites assessed in previous SHLAA reviews.
